East Japan Disaster- Preliminary Report

Association of Japanese Consulting Engineers (AJCE)

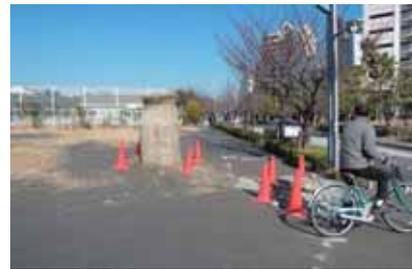
Uplifted manhole by liquefaction
 Photo: Nihon Suido Cosultants

Liquefaction occurred in the bed-town areas of Tokyo and caused stoppage of sewage system. This area was developed by landfill and locates in the coastal area of Tokyo bay. Liquefaction was observed not only in the coastal areas but also inland housing areas that were developed by landfill over the past riverbed.

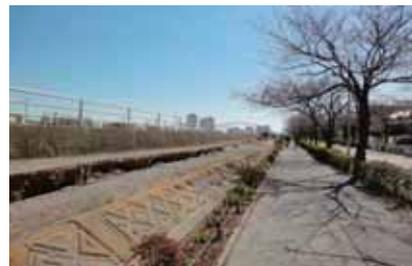
Bumped seawall caused by liquefaction
 Photo: Chuo Kaihatsu

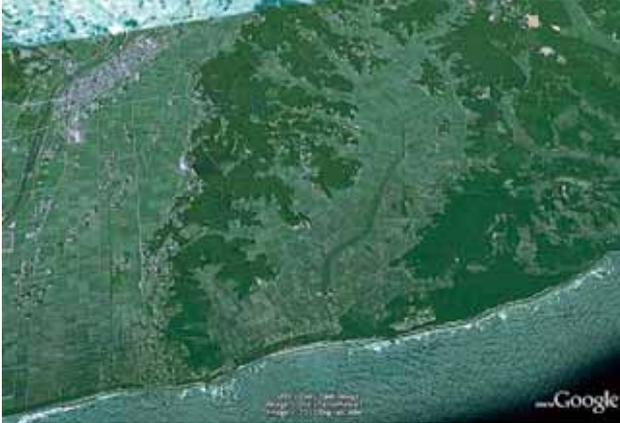
Minami-Soma City, 2006

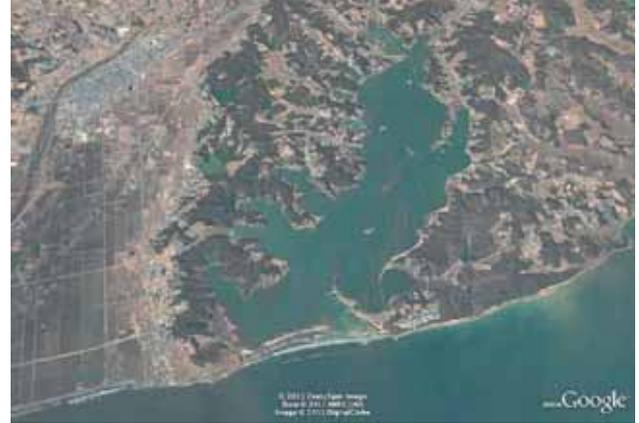
Minami-Soma City, Tsunami induced water reached Inland ©2011 Google, GeoEye

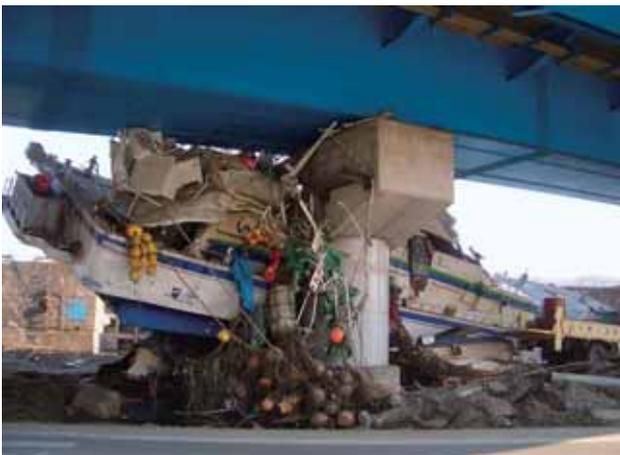
Ship drifted by Tsunami was trapped by bridge pier

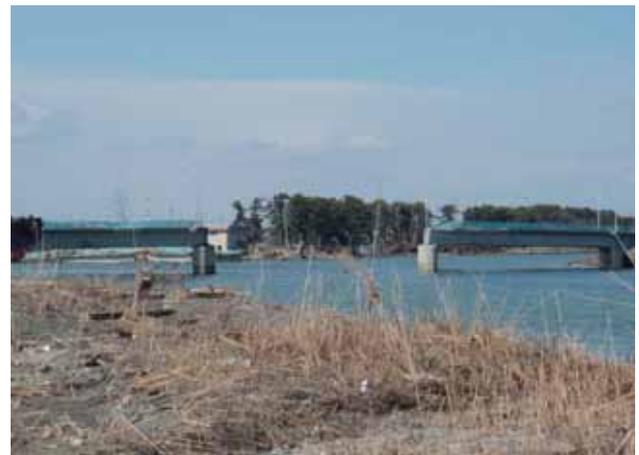
Center bridge girder was taken away by Tsunami
Photo: Oriental Consultants

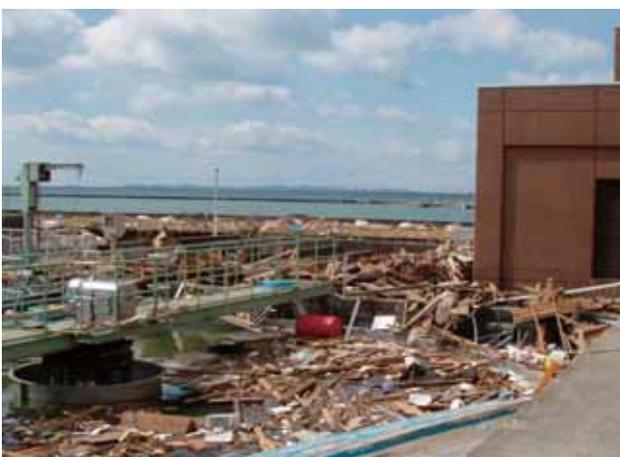
Sewage treatment facility blocked by a heap of rubble

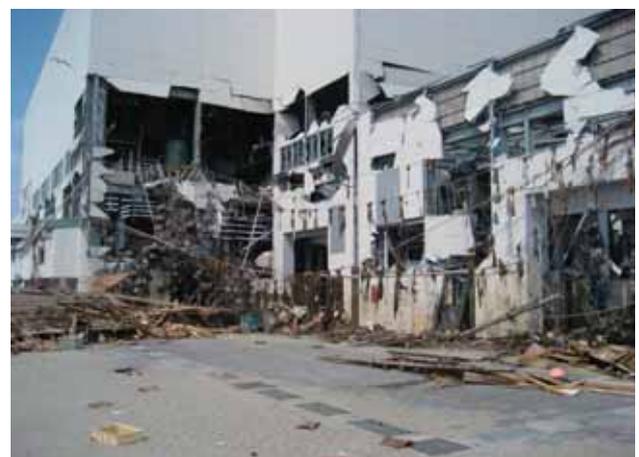
Sewage treatment facility tangled by fish nets
Photo: Nihon Suido Consultants

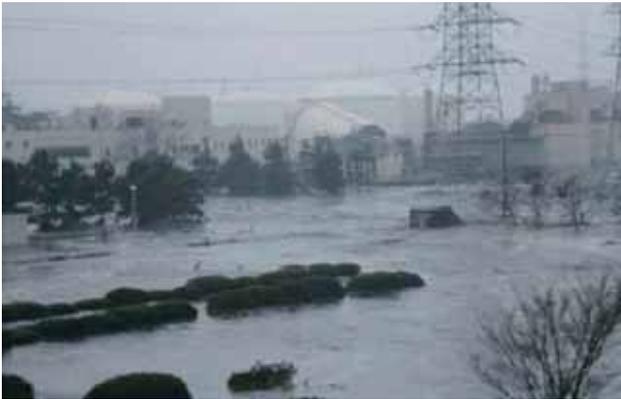
Site of flooded sewage treatment Facility

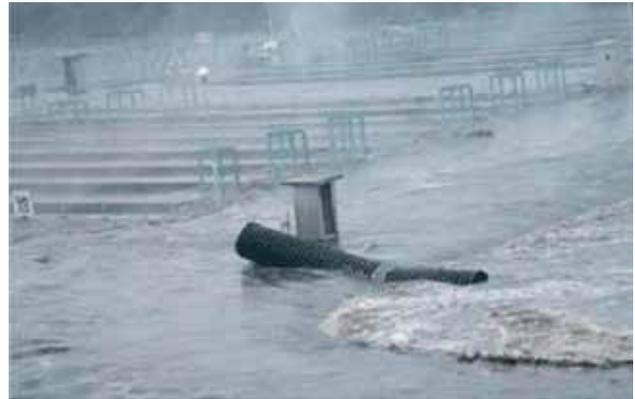
Flooded sewage treatment facility
Photo: Tokyo Engineering Consultants

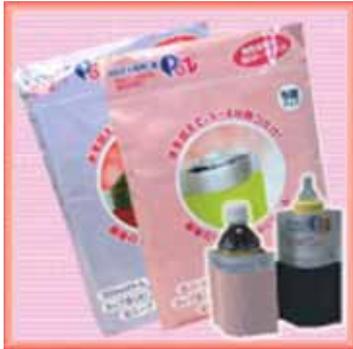
【Portable Water Heater】
 Jointly developed by Chodai and Pal corporation.

It contains aluminum bag, heat-inducing agent and water. After mixing water and heat-inducing agent in aluminum bag, it generates heat by chemical reactions. It can be used for heating baby bottle, pet bottle or canned drink. Temperature in the afflicted areas in March recorded below 3 degree C. Warm drink was appreciated at the devastated area where no gas and electricity were available.
